PUERTO RICO INTERNATIONAL AIRPORT

Runway Repairs Returned
Back to Service in Less Than
Two Hours

PROJECT PROFILE

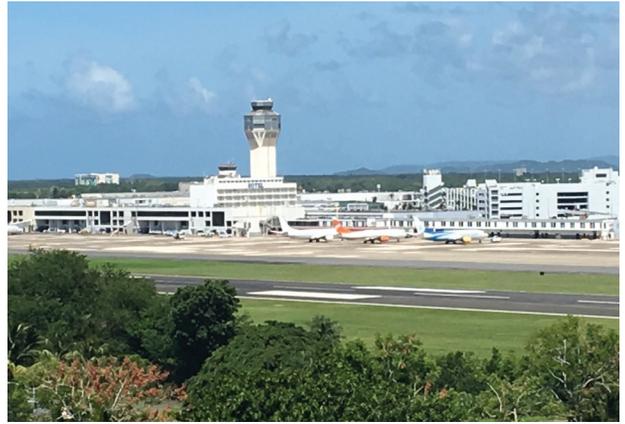
Crews return repaired areas back to service in less than two hours.

Once personnel were trained, Aerostar launched the runway maintenance program with great success. So far, more than 25 percent of damaged concrete has been replaced. As was hoped, crews have been able to return repaired areas back to service in less than two hours.
